**Flood Control Project Maintenance  
Levee Inspections****LMA District Cover Sheet****Spring 2013 Levee Inspection Results****Reclamation District No. 0150 Merrit Island**

**Spring 2013 Levee Inspection Results**

**Reclamation District No. 0150 Merrit Island**

Waterway			Bank	Unit Miles
Unit No. 01 Sutter Slough			Left	0.54
	Spring (March - May)	Summer (June - August)	(September - November) Fall	Winter (December - February)
Unit Maintenance Rating (Fall Only)				
Date of Inspection	03/14/2013 - 03/14/2013			
DWR Inspector	Pavel Kazi			
Accompanied By

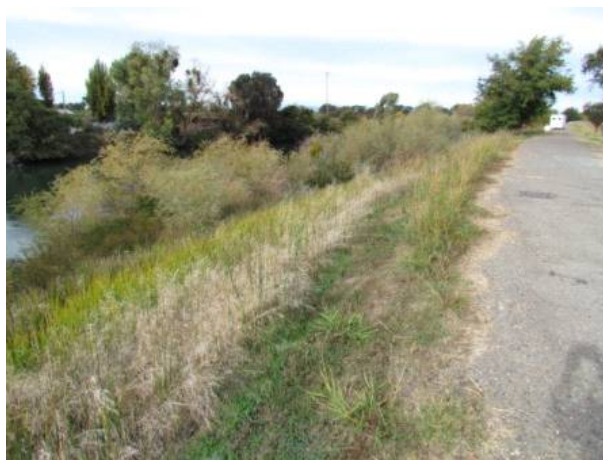
Levee Mile Report Line	4
Start Levee Mile	0.03
End Levee Mile	0.41
Location	Water Side
Category	
Item	Vegetation
Vegetation was found on the waterside of the levee looking upstream.	
pkazi_s_20130304_521.jpg

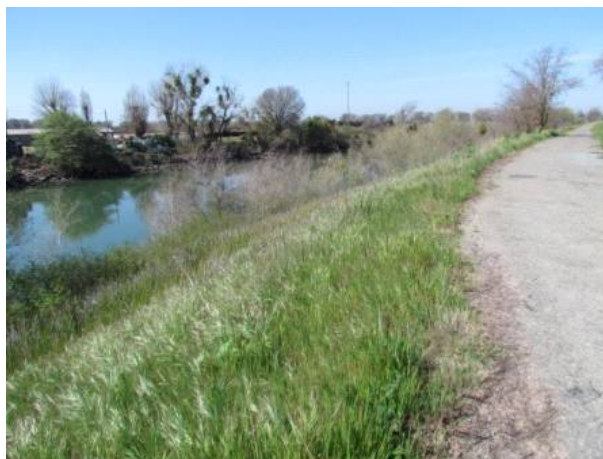
Levee Mile Report Line	4
Start Levee Mile	0.03
End Levee Mile	0.41
Location	Water Side
Category	
Item	Vegetation
Vegetation was found on the waterside slope of the levee looking upstream during spring 2013 inspection.	
pkazi_s_20130315_898.JPG

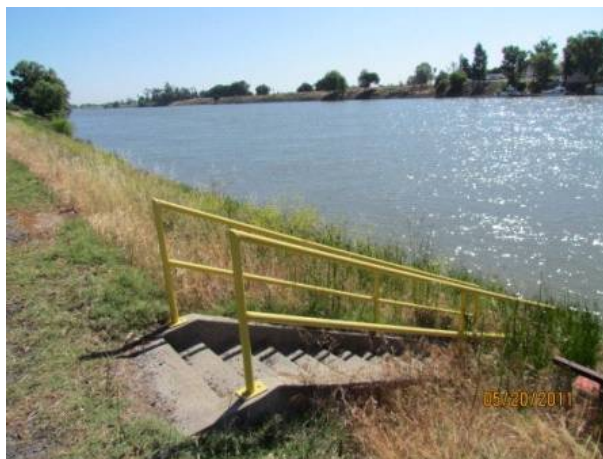
Levee Mile Report Line	8
Start Levee Mile	0.39
End Levee Mile	0.39
Location	Water Side
Category	
Item	Encroachments
A stairway was found on the waterside of the levee. The picture was taken from the crown looking upstream.	
pkazi_s_20130304_532.jpg

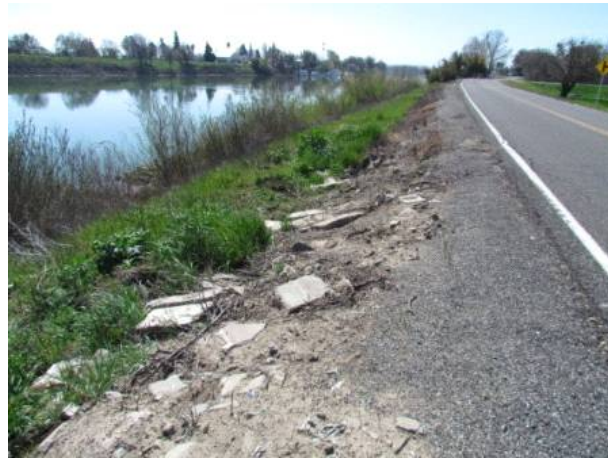
pkazi\_s\_20130319\_901.JPG

Debris was found on the waterside slope of the levee looking downstream during Spring 2013 inspection.

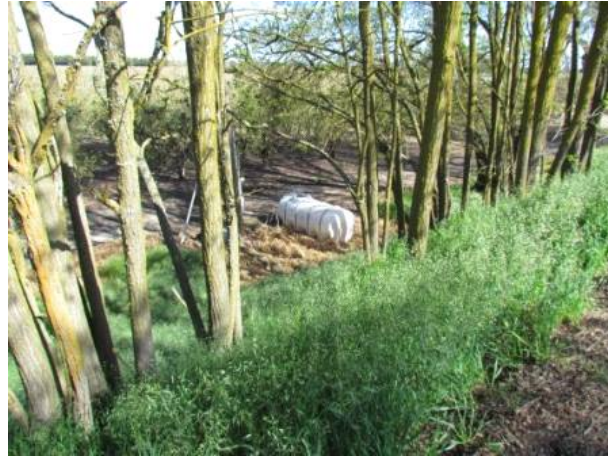
Levee Mile Report Line	22
Start Levee Mile	2.75
End Levee Mile	2.75
Location	Land Side
Category	
Item	Encroachments
A tank was found on the landside toe of the levee looking upstream.	
pkazi_s_20130304_538.jpg

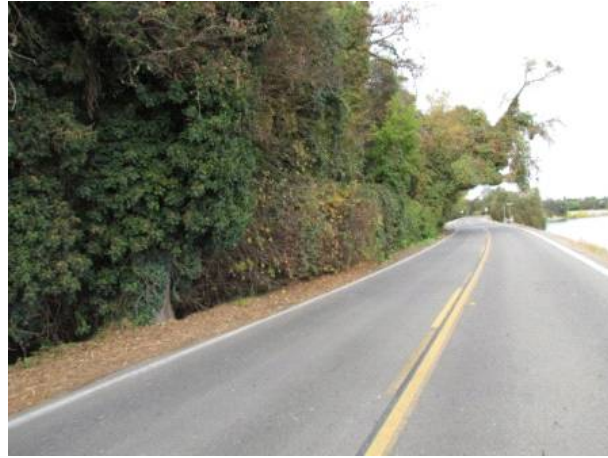
Levee Mile Report Line	43
Start Levee Mile	4.98
End Levee Mile	4.98
Location	Land Side
Category	
Item	Trim / Thin Trees

Tree stumps were found on the landside of the levee looking from the crown.

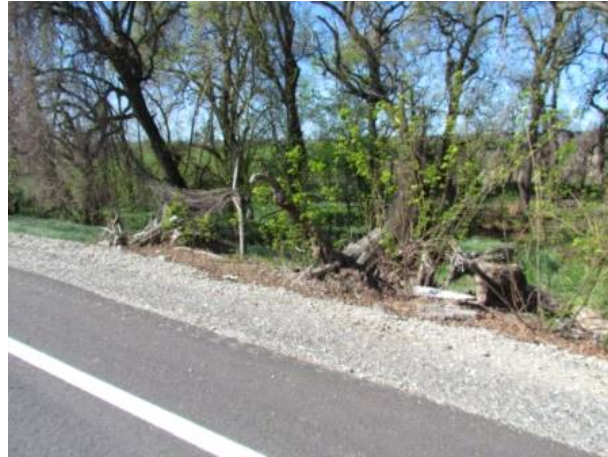
Levee Mile Report Line	44
Start Levee Mile	5.14
End Levee Mile	5.17
Location	Land Side
Category	
Item	Vegetation

Landscaping was found on the landside shoulder of the levee looking upstream.

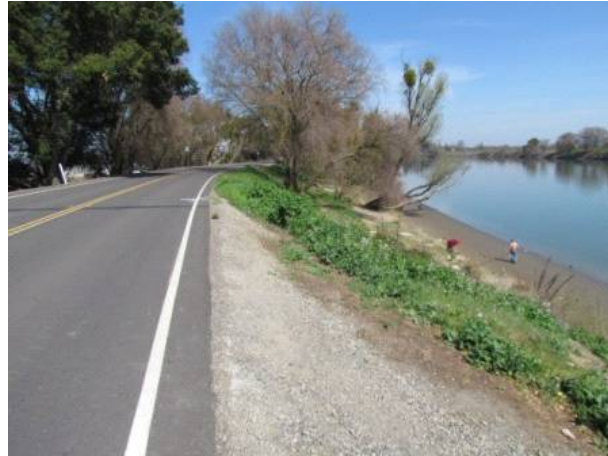
Levee Mile Report Line	49
Start Levee Mile	5.34
End Levee Mile	7.91
Location	Water Side
Category	
Item	Vegetation
Vegetation was found waterside slope of the levee looking upstream during spring 2013 inspection.	
pkazi_s_20130320_911.JPG

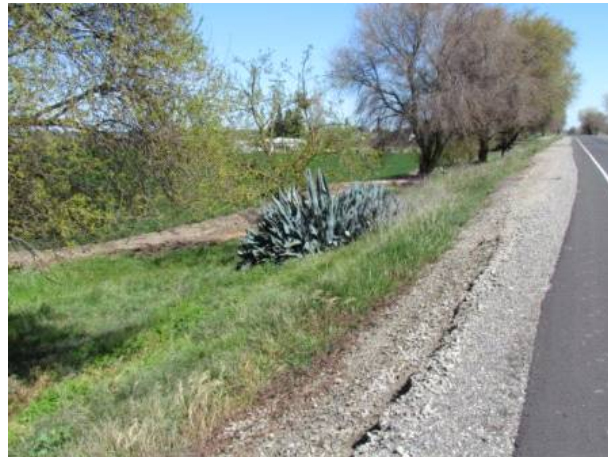
Levee Mile Report Line	51
Start Levee Mile	6.18
End Levee Mile	6.18
Location	Land Side
Category	
Item	Vegetation
Century plant and vegetation was found on the landside of the levee looking upstream.	
pkazi_s_20130304_540.jpg

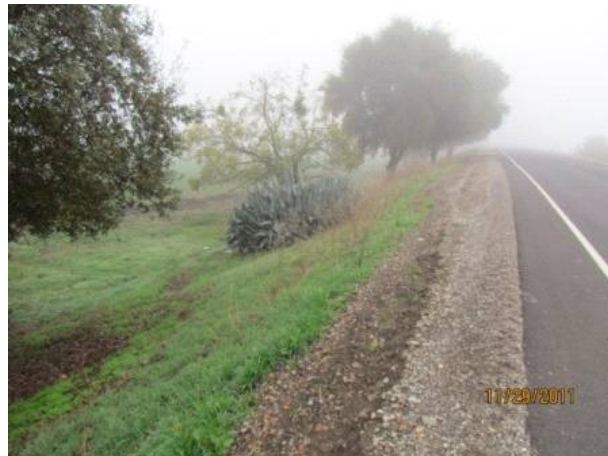
Levee Mile Report Line	52
Start Levee Mile	6.41
End Levee Mile	6.41
Location	Land Side
Category	
Item	Vegetation
Century plant was found on the landside of the levee looking upstream.	
pkazi_s_20130304_541.jpg

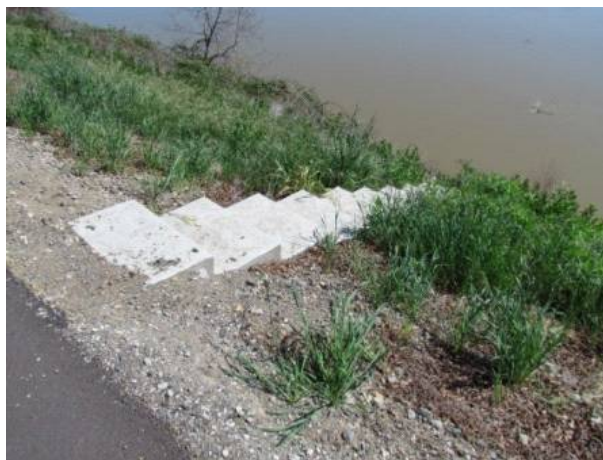
Levee Mile Report Line	57
Start Levee Mile	6.59
End Levee Mile	6.59
Location	Water Side
Category	
Item	Encroachments
A stairway was found on the waterside slope of the levee looking upstream.	
pkazi_s_20130304_548.jpg

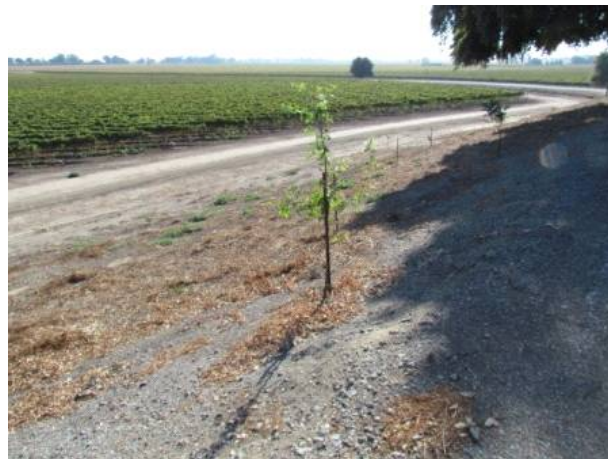
Levee Mile Report Line	15
Start Levee Mile	2.60
End Levee Mile	2.60
Location	Land Side
Category	
Item	Trim / Thin Trees
View of tree stumps on the landward slope.	
pkazi_s_20130304_583.jpg

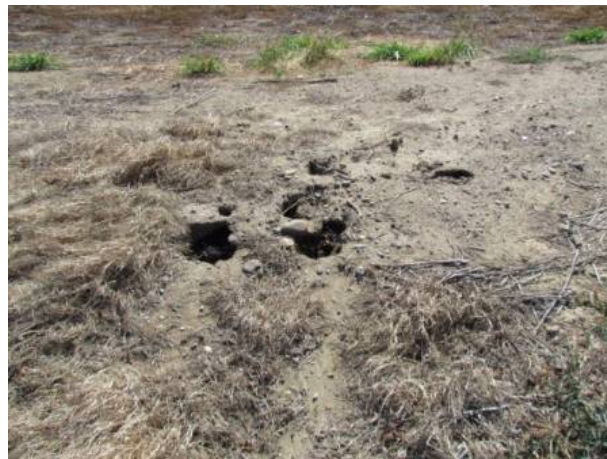
Levee Mile Report Line	27
Start Levee Mile	3.34
End Levee Mile	3.34
Location	Land Side
Category	
Item	Encroachments
Material was found on the landside of the levee looking downstream.	
pkazi_s_20130304_641.jpg

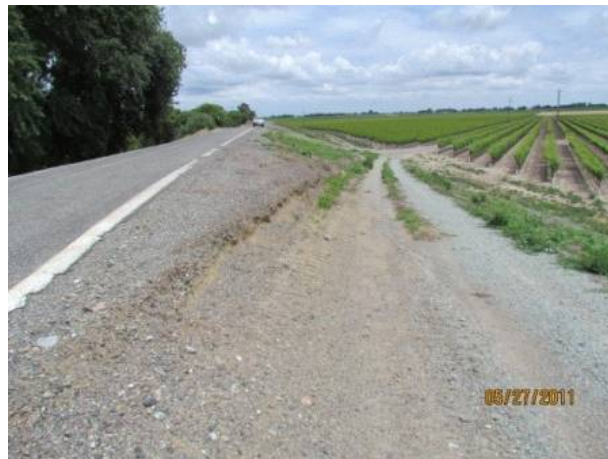
Levee Mile Report Line	35
Start Levee Mile	3.77
End Levee Mile	3.77
Location	Water Side
Category	
Item	Slope Stability
Slope instability was repaired by the LMA on the waterside slope of the levee looking downstream.	
pkazi_s_20130320_924.JPG

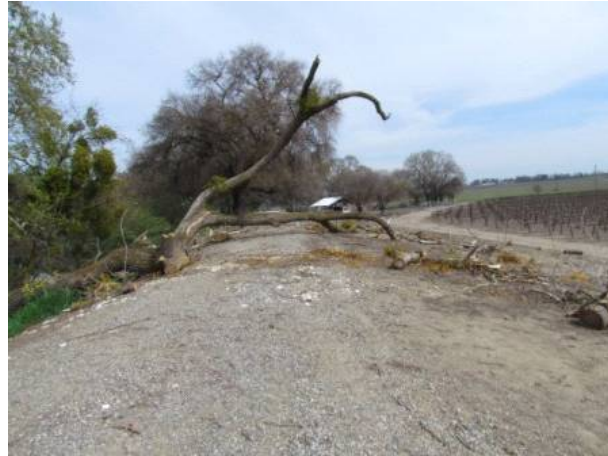
Levee Mile Report Line	54
Start Levee Mile	5.88
End Levee Mile	5.88
Location	Water Side
Category	
Item	Vegetation
Wild growth was found on the waterside slope of the levee looking upstream.	
pkazi_s_20130304_599.jpg

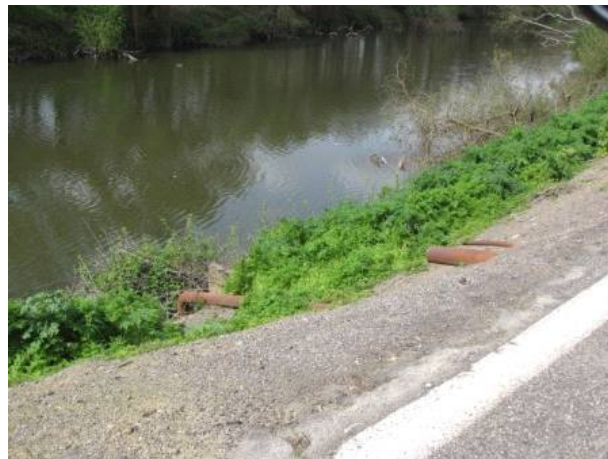
Levee Mile Report Line	61
Start Levee Mile	6.14
End Levee Mile	6.14
Location	Water Side
Category	
Item	Encroachments
An abandoned dock was found on the waterside of the levee looking upstream.	
pkazi_s_20130304_608.jpg
